**ARROYO LAS POSAS  
AND  
ARROYO SIMI  
ARUNDO REMOVAL FEASIBILITY  
AND  
WATER SAVINGS STUDY**

January 2015

Ventura County Water and Sanitation Department  
6767 Spring Road  
Moorpark, California 93021

Wildscape Restoration, Inc.  
2500 Channel Drive Suite A-1  
Ventura, California 93003

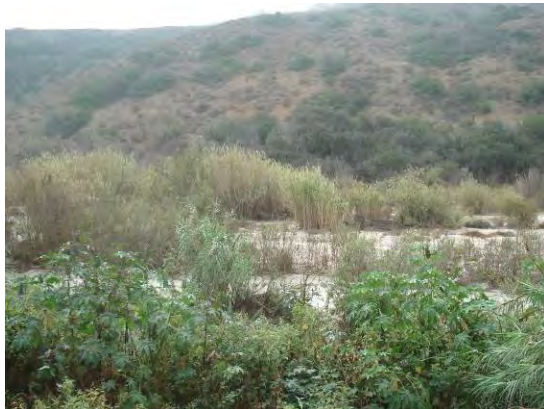
1. View southeast at Long Canyon in Arroyo Las Posas of a typical 1 - 49% cover class. September 5, 2014.

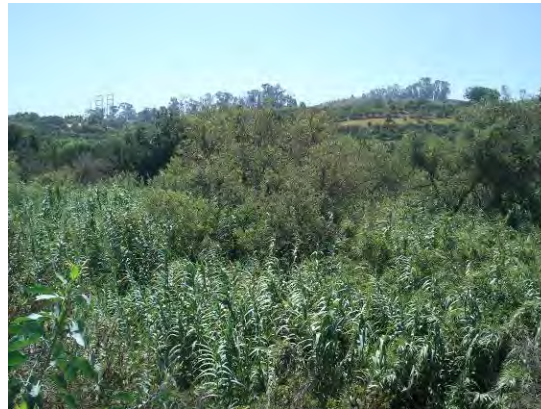
2. View southwest at Mejico Creek in Arroyo Las Posas of typical 50% - 75% cover class. September 5, 2014

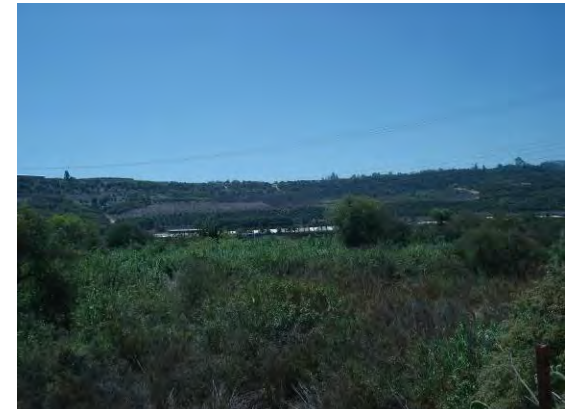
3. View looking west from Hitch Blvd. at a typical greater than 75% cover class. September 5, 2014.

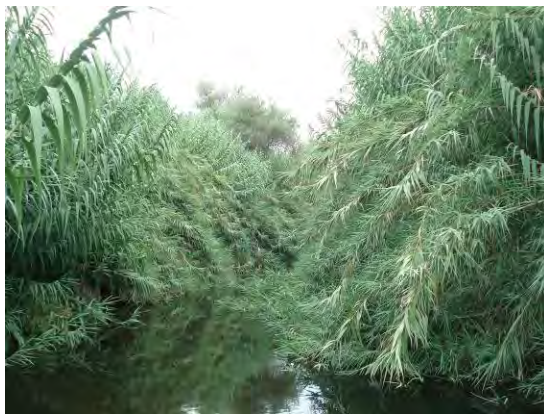
4. View looking east from weir in Arroyo Simi. 100% cover in immediate riparian corridor. September 8, 2014.

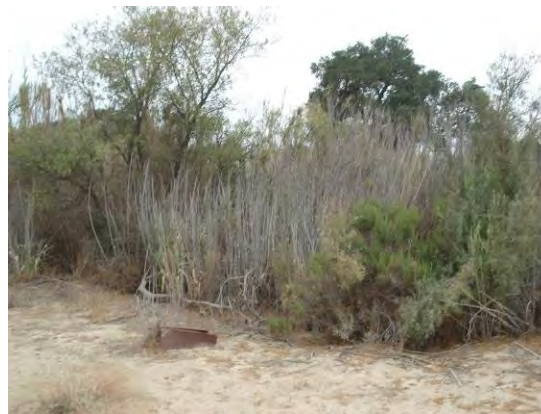
5. Arroyo Simi, old mature stands intermixed with native riparian vegetation. 1% - 49% cover. September 8, 2014

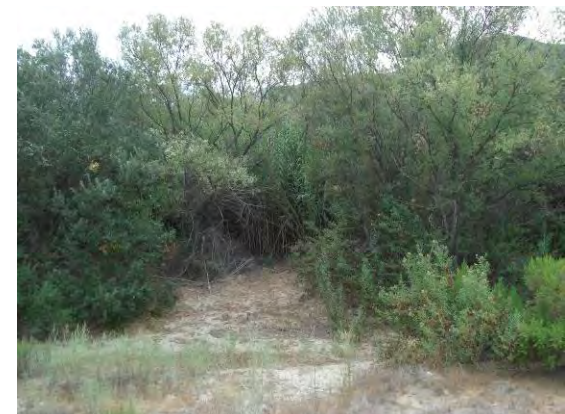
6. Arroyo Simi, new stand intermixed with riparian vegetation. Less than 1% cover. September 9, 2014
